An Taisce
The National Trust for Ireland

Buildings at Risk

November 2014

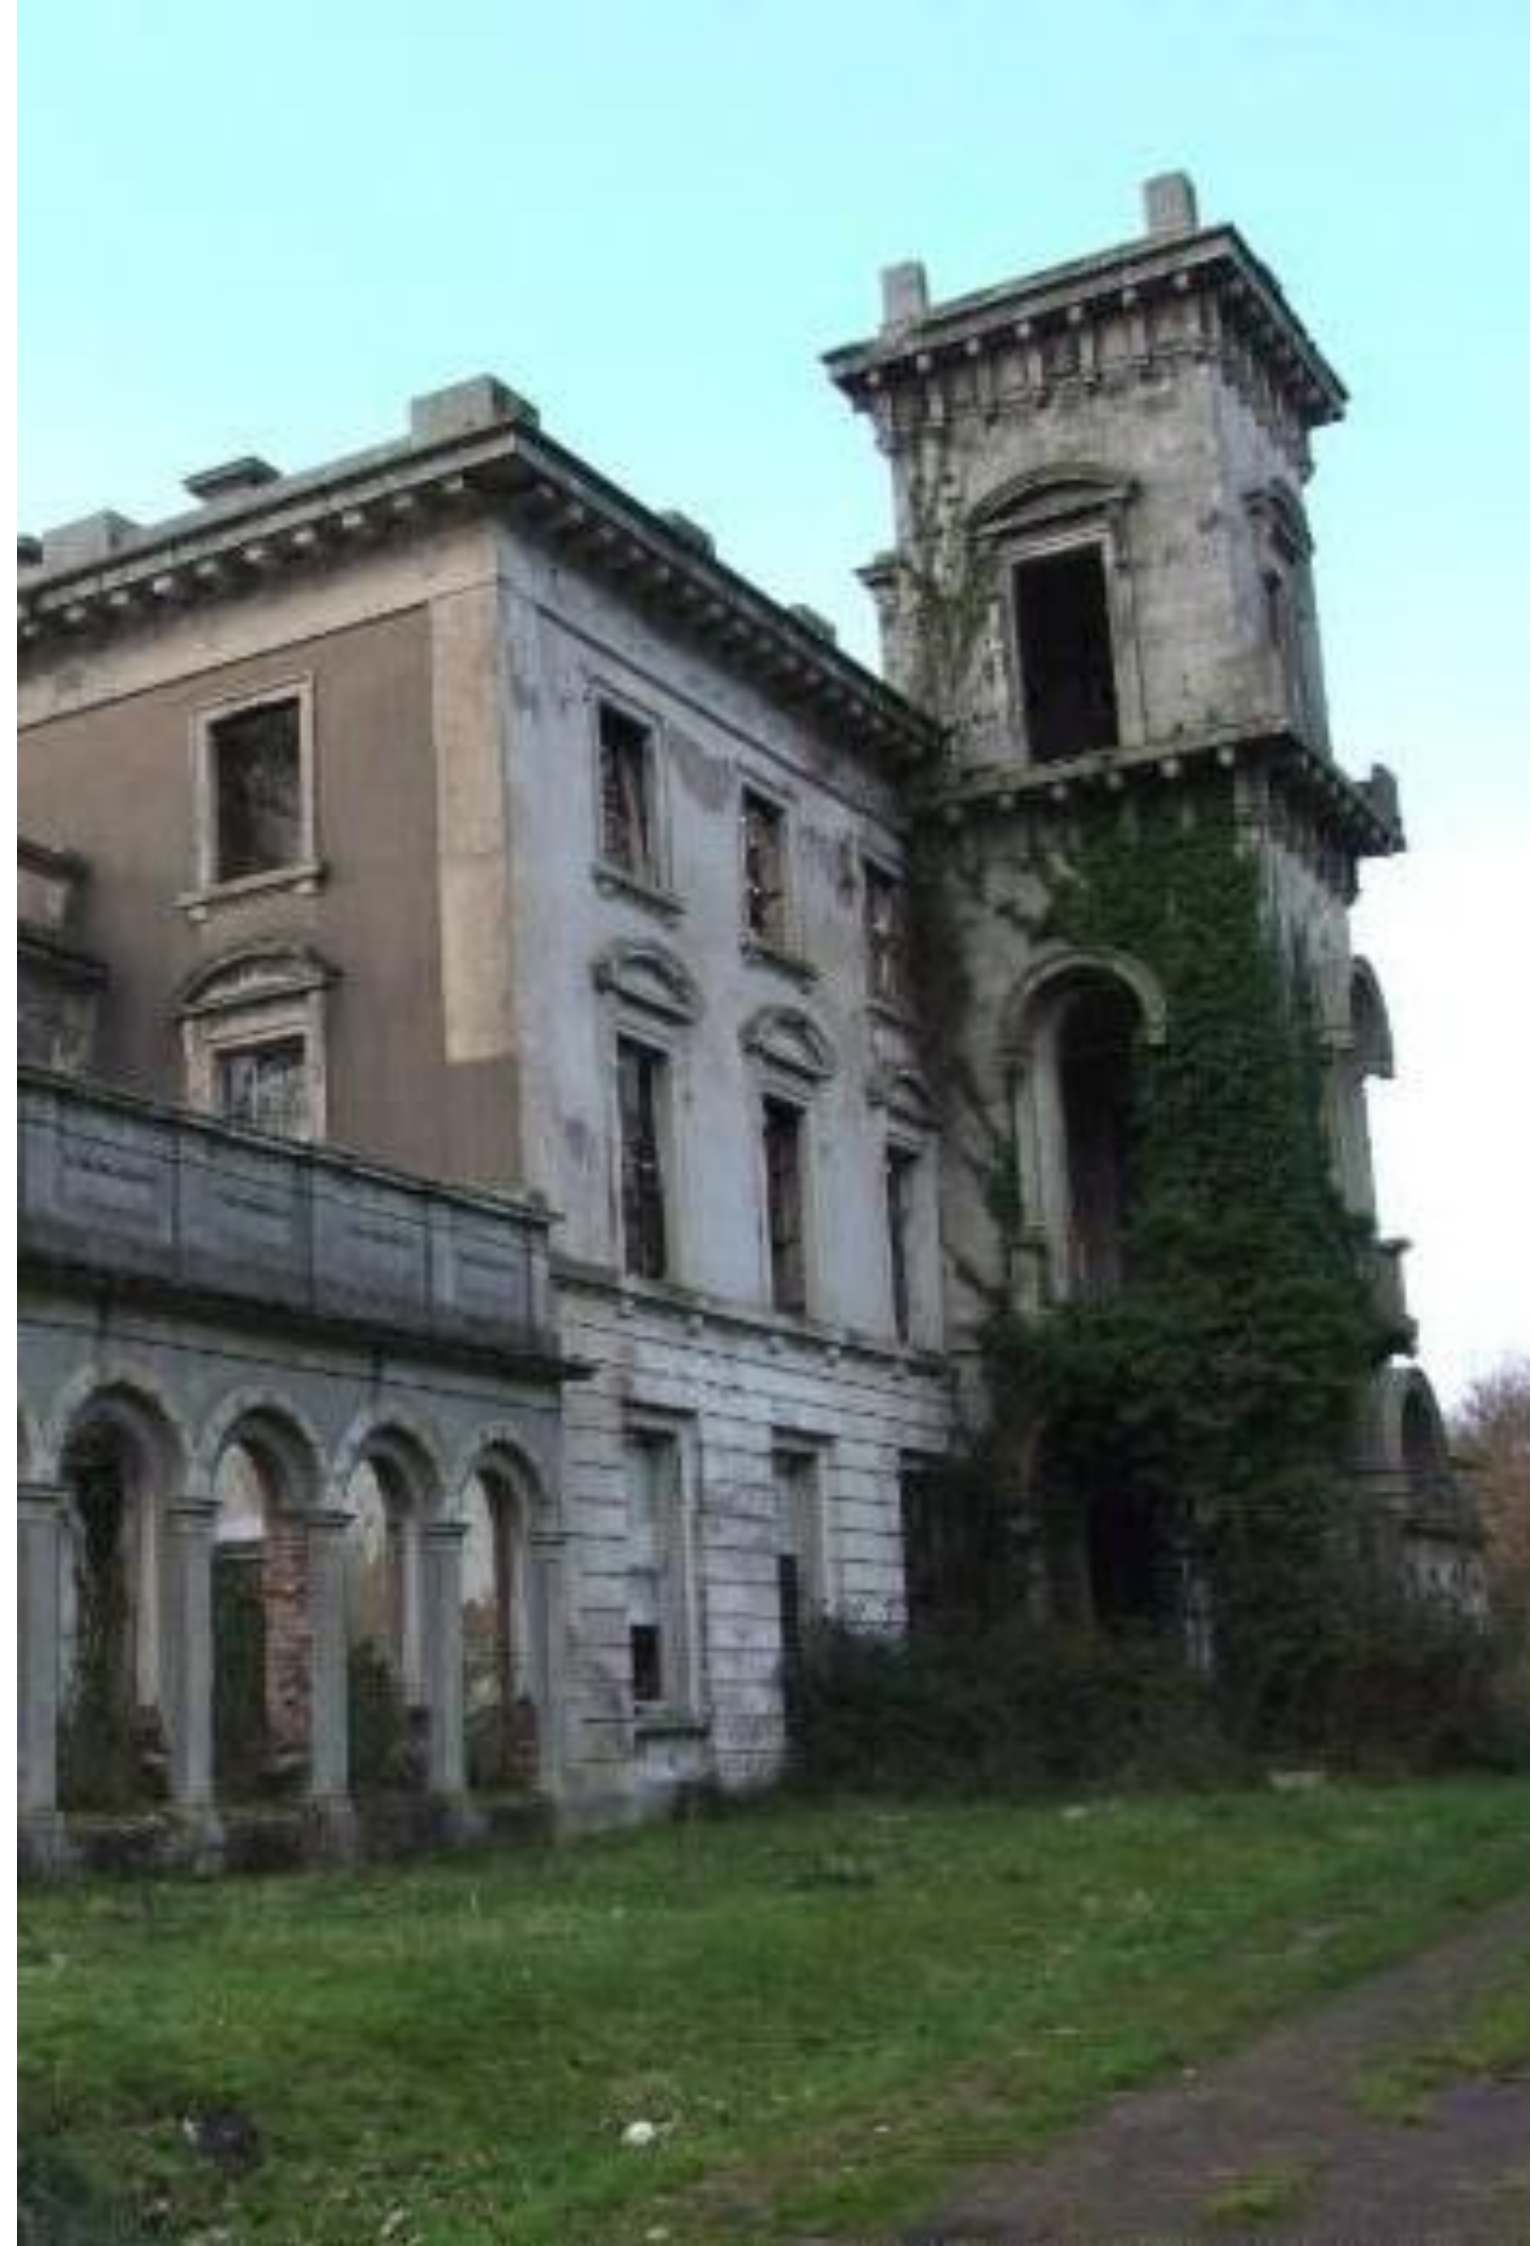
Portlaw Cotton Factory

One of the largest 19th century structures in Ireland, similar to cotton factories found in Lancashire in the United Kingdom. The site has been abandoned, falling into decay and increasingly being overcome by vegetation in recent years. The structure is of significant historic importance and requires conservation works to prevent further deterioration.

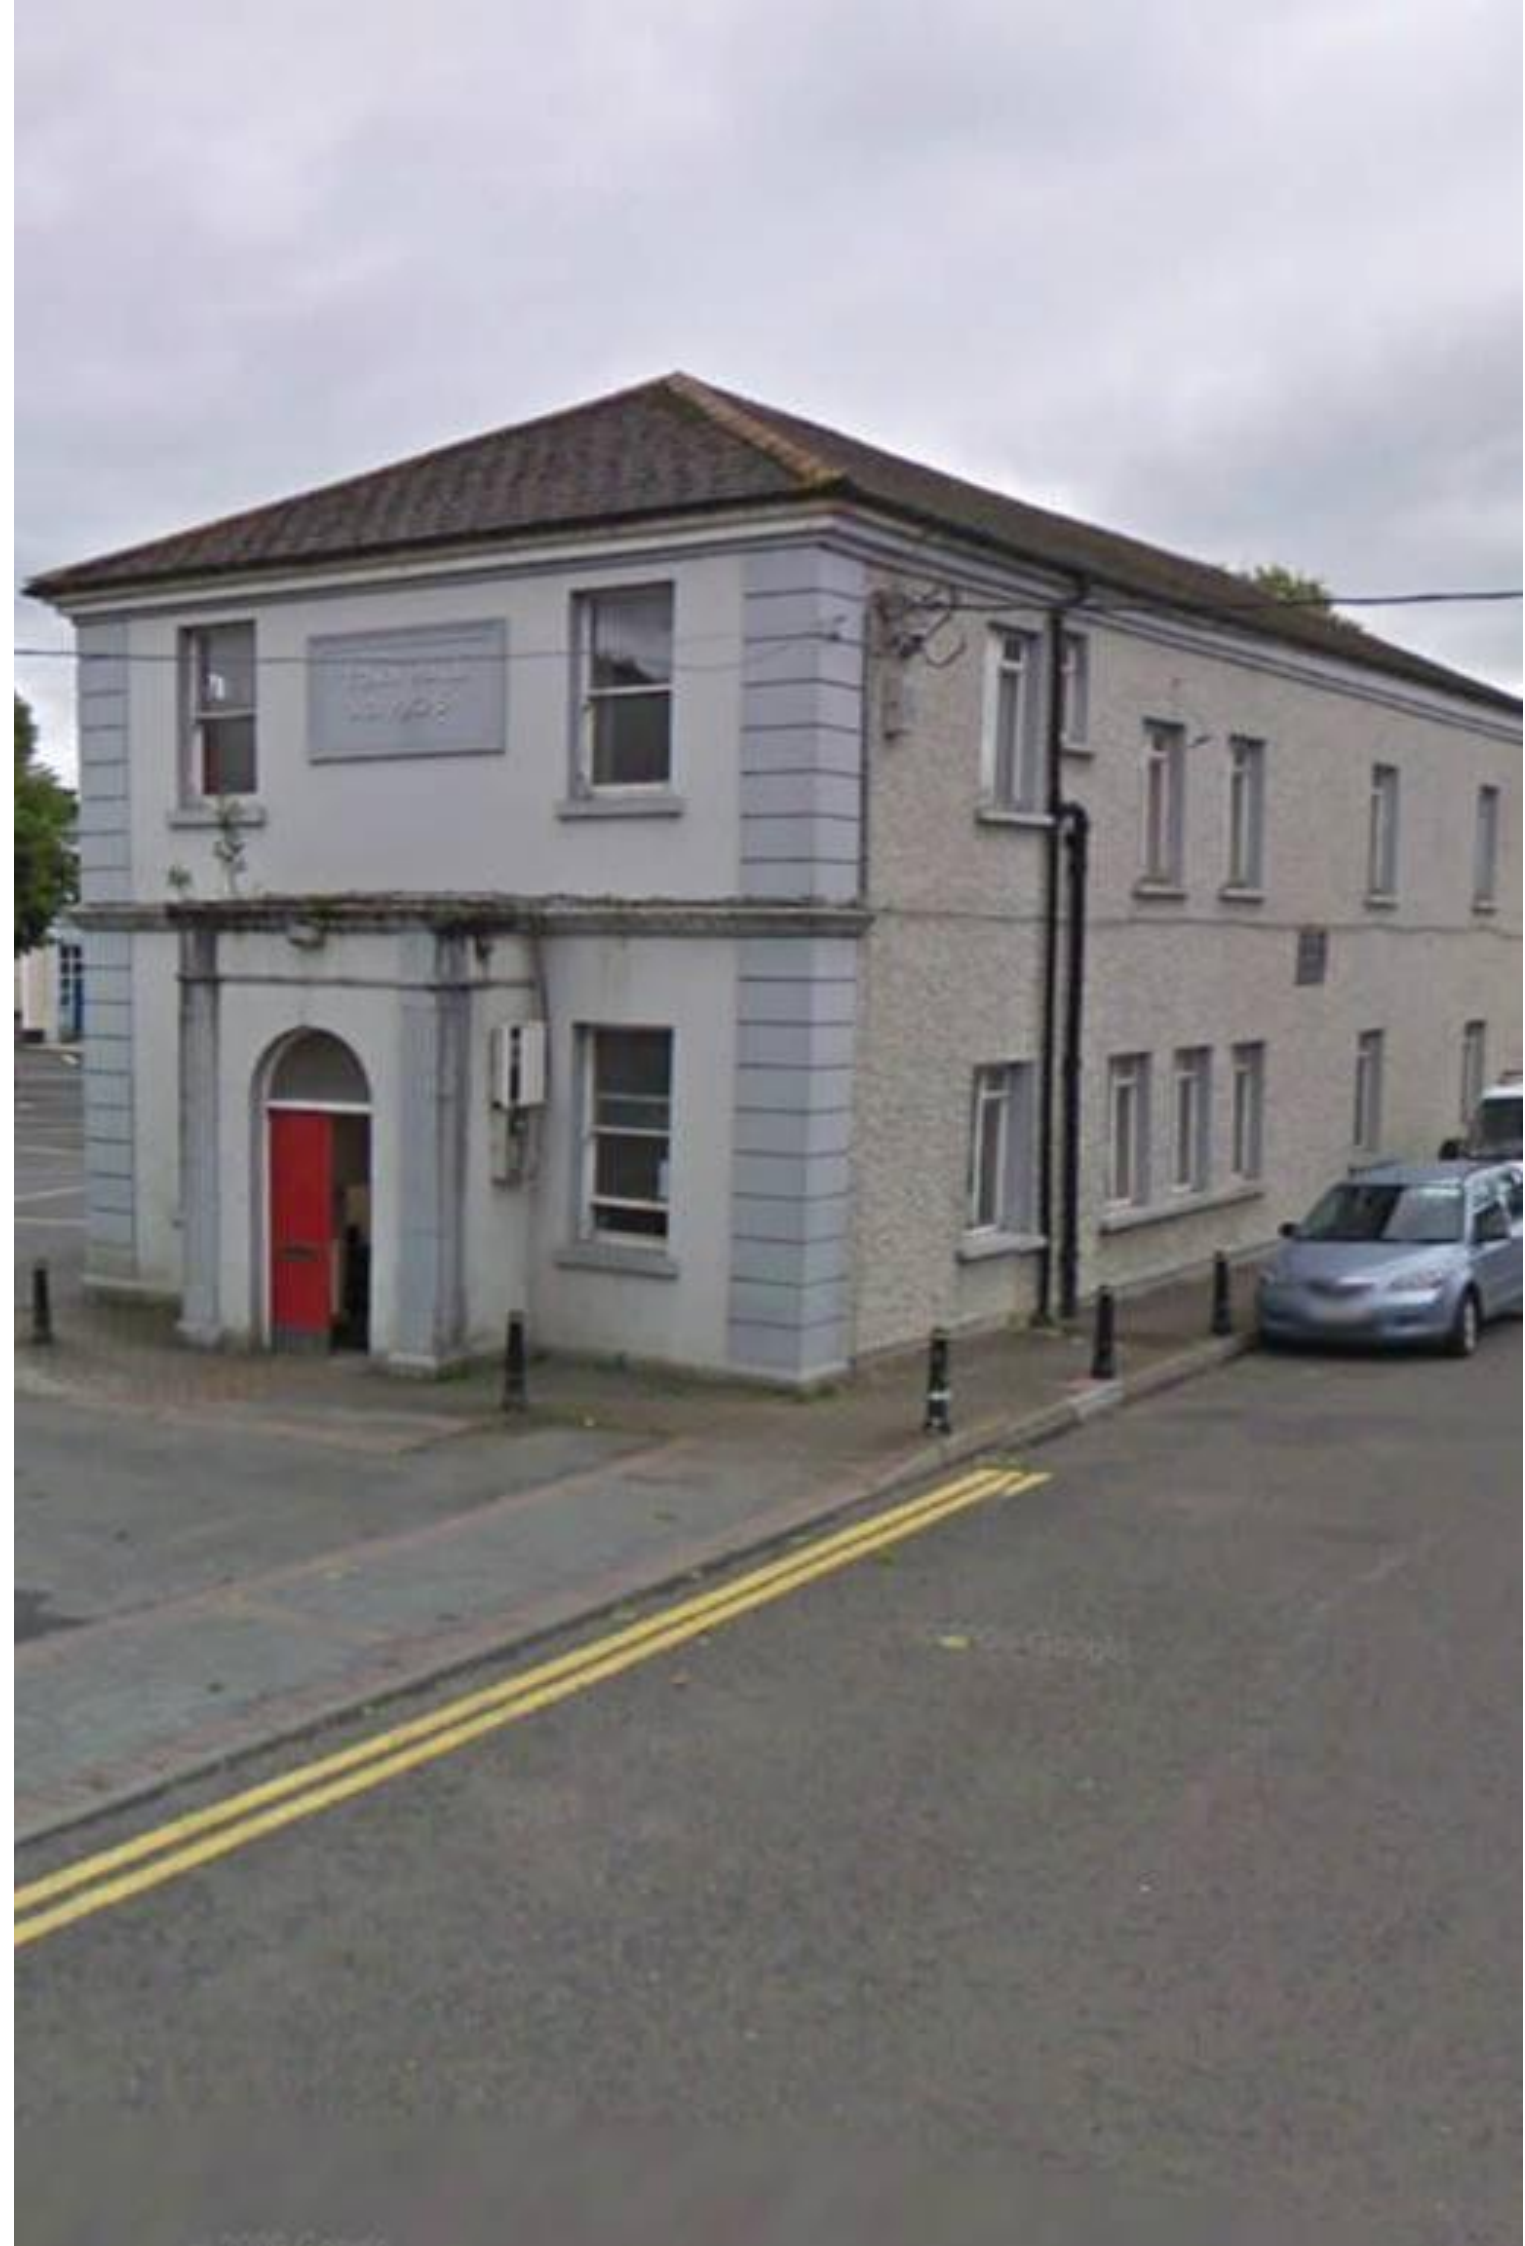
Condition of Structure	Poor
Level of Risk	Moderate

The building has been vacant for a number of years and does not appear to be maintained. Most of the external fabric remains, but there are obvious signs of deterioration such as slipped slates, vegetation growth, broken windows, vandalism, or blocked rainwater goods. There are concerns that the building could suffer further decay leading to more serious problems.

The Market House in Castlepollard, Co. Westmeath is not a protected structure but is of high architectural value being a late Georgian Market House with 20th century alterations. Forms focal point of village green. The building is currently vacant. An Taisce Westmeath Association has put forward proposal for restoration of building to original character for an appropriate use which would restore its function as a central focus of the village.

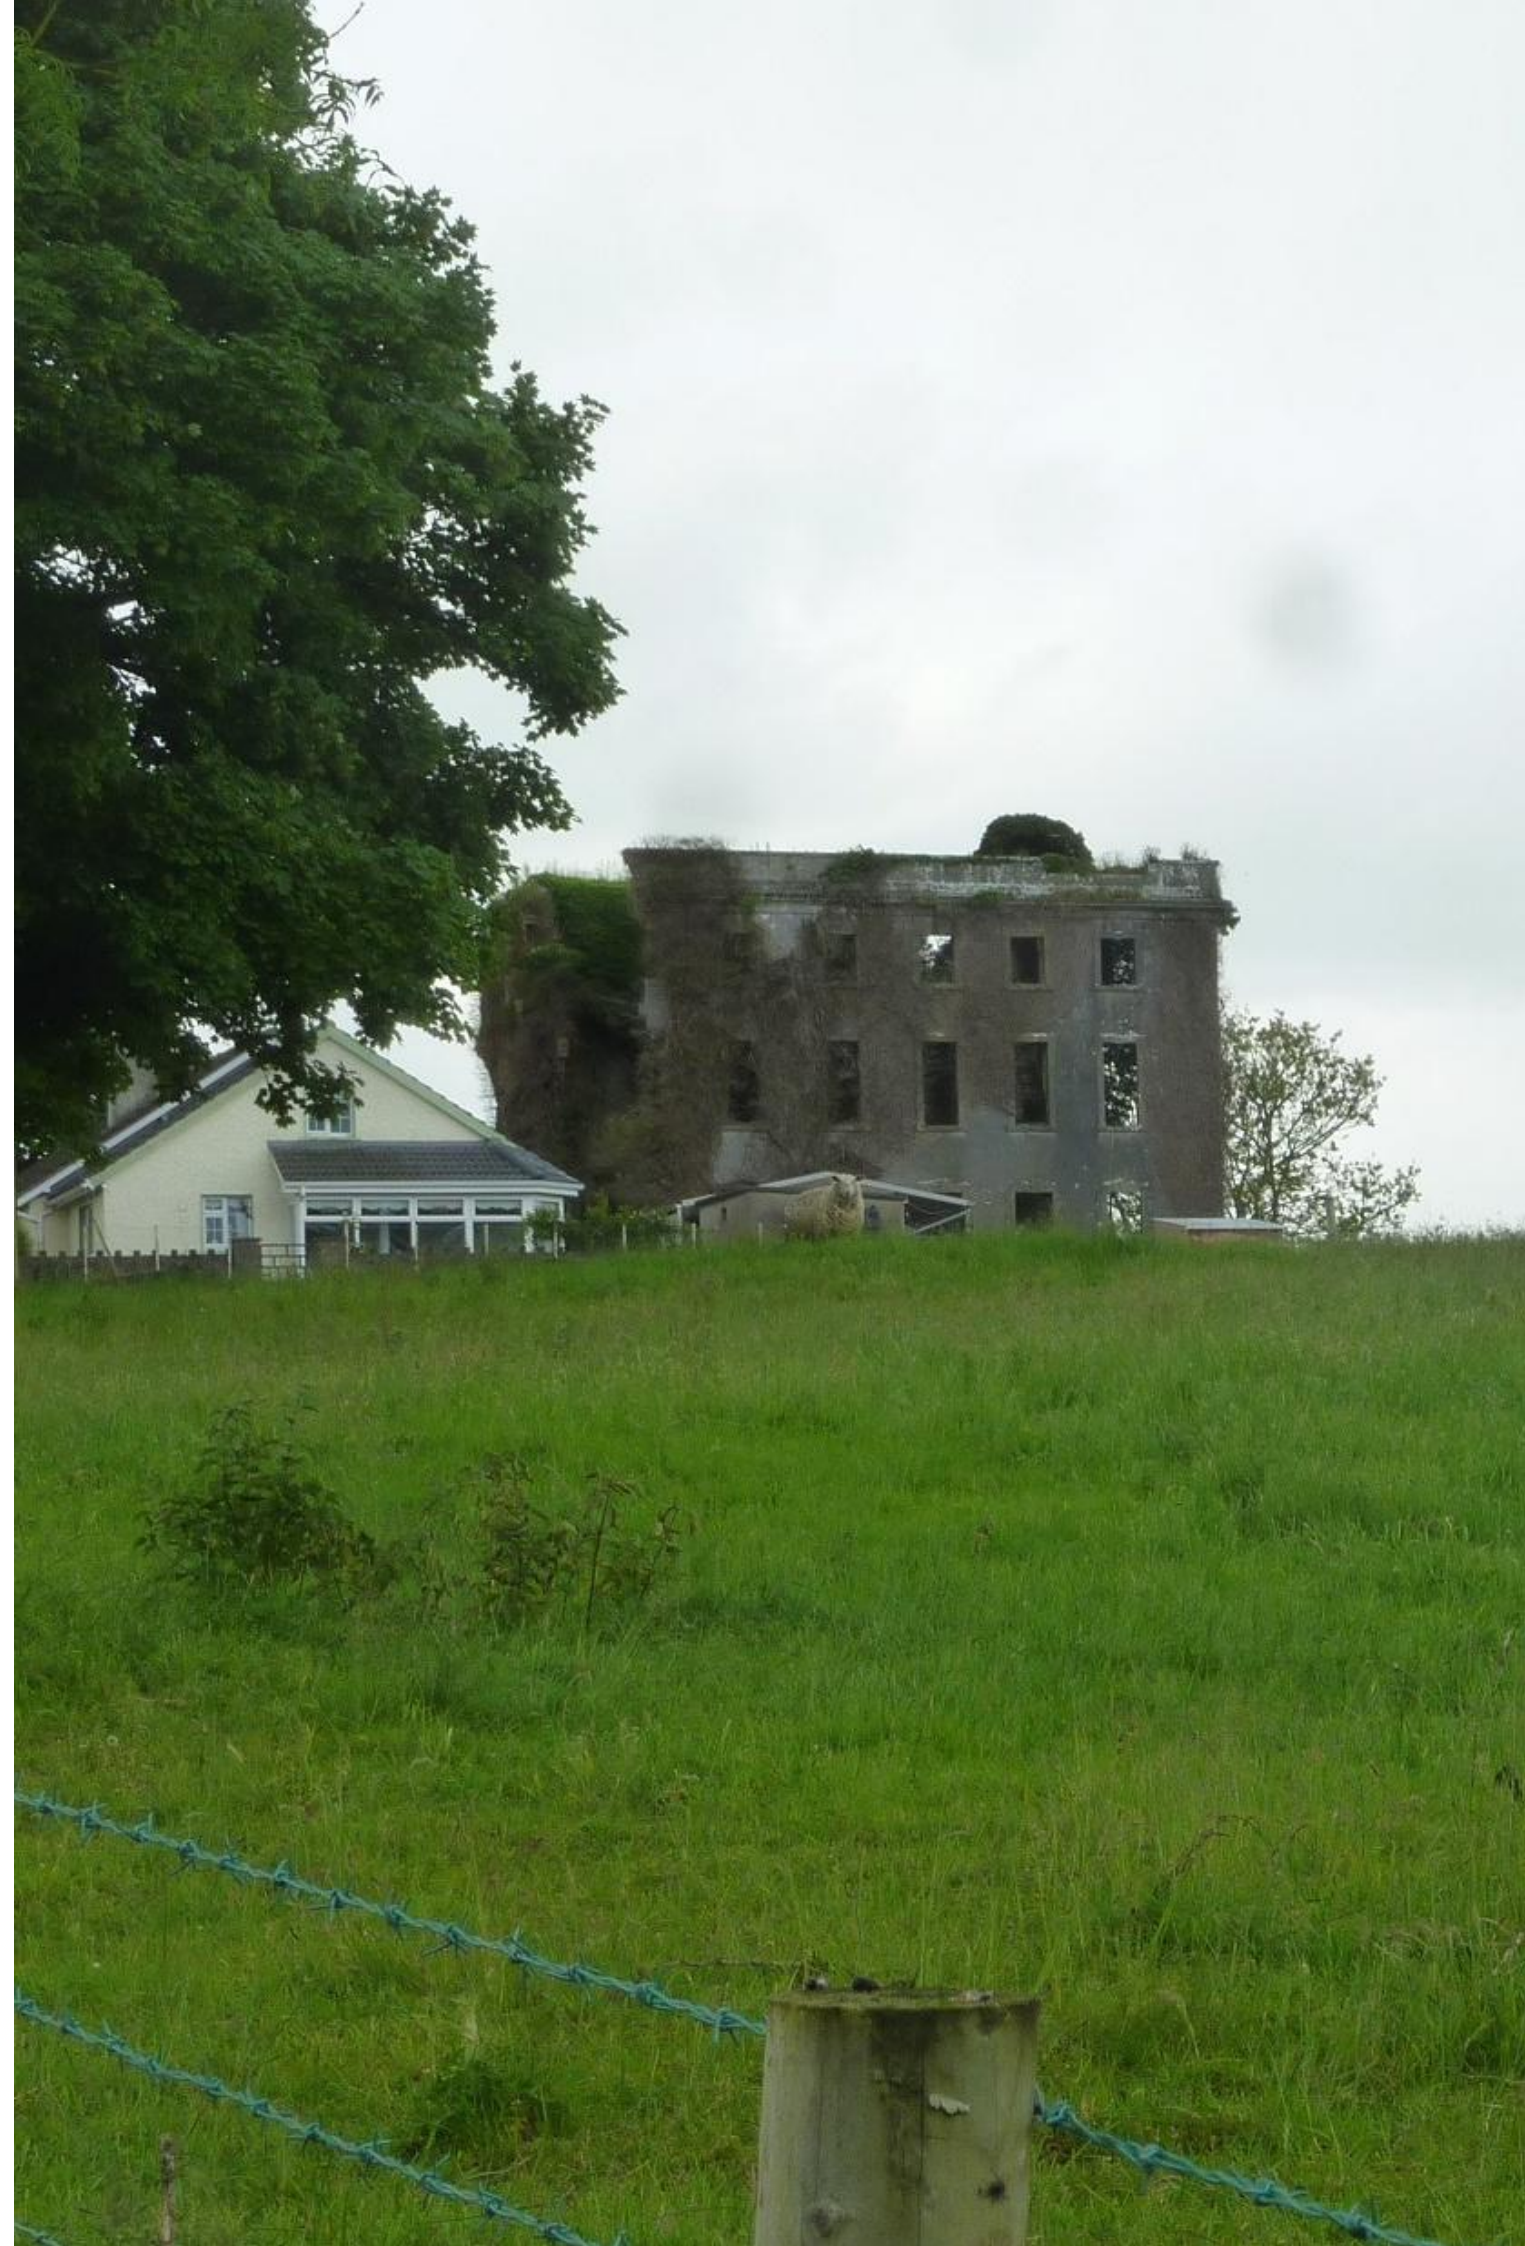
Waterstown House

Vacant with no identified new use	
Suffering from neglect and/or poor maintenance	X
Suffering from structural problems	
Fire damaged	
Threatened with demolition	
Ruin which is poorly maintained	X

Condition of Structure	Ruinous
Level of Risk	High

This complex has been abandoned for a number of years and does not appear to be maintained. Most of the external fabric remains, but there are obvious signs of deterioration, particularly vegetation growth. There is no immediate danger of collapse but the condition is such that unless urgent remedial works are carried out the structure will sharply deteriorate.

This grand walled garden, currently in use as a farmyard complex, is associated with the larger demesne house of Waterstown which is located south west of the ruinous 18th century house (pictured) which is now engulfed with vegetation. The gardens were laid out by Richard Castle, who also designed Waterstown House. The garden, through its design, was able to accommodate exotic fruits and vegetables. The garden is a rare example of its kind in Ireland. The complex is of significant historic importance and requires conservation works to prevent further deterioration.

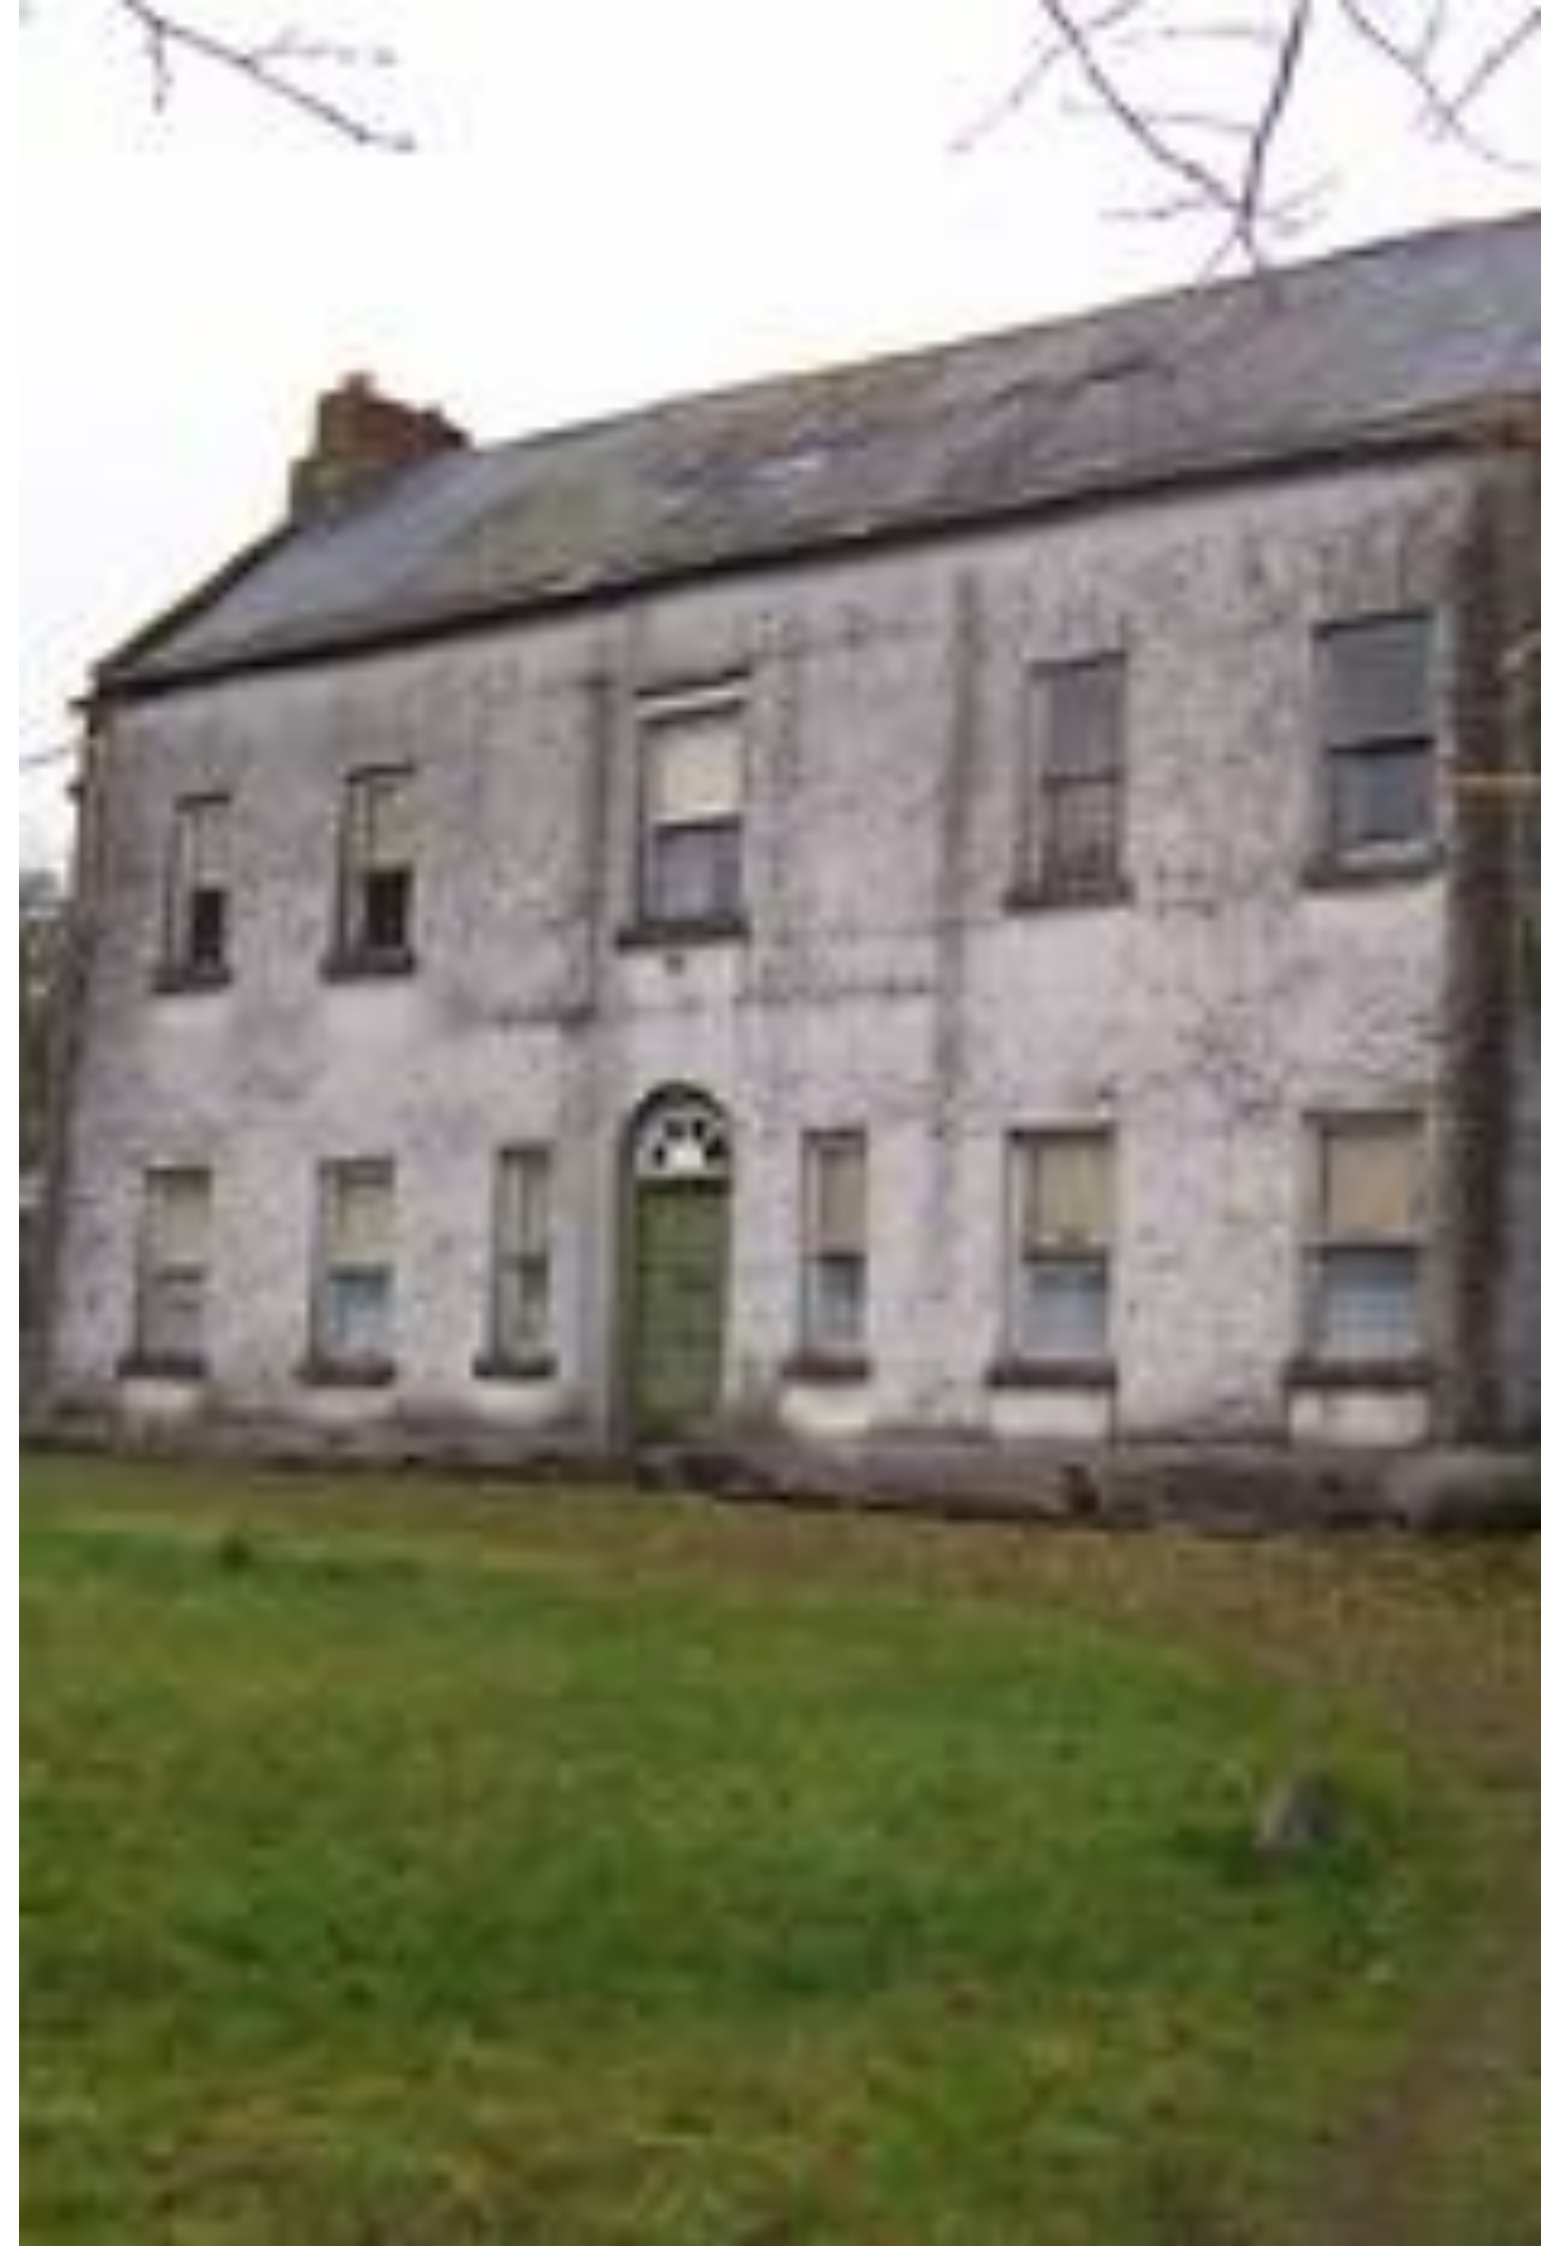
Killagh House

Vacant with no identified new use	X
Suffering from neglect and/or poor maintenance	X
Suffering from structural problems	
Fire damaged	
Threatened with demolition	
Ruin which is poorly maintained

Condition of Structure	Very Poor
Level of Risk	High

The building is suffering from major conservation problems. Most of the external fabric remains, but there are obvious signs of deterioration such as slipped slates, vegetation growth, broken windows and vandalism. There is no immediate danger of collapse but condition is such that unless urgent remedial works are carried out the building will sharply deteriorate.

Killagh is an unusual early 18th century house, simple in form, which has remained vacant for some time. With no ongoing maintenance some features are falling derelict such as the early eighteenth century timber door with raised and fielded panels and an unusual three-spoke fanlight with heavy glazing bars over. This building urgently requires new uses to be identified to prevent further deterioration of its character.

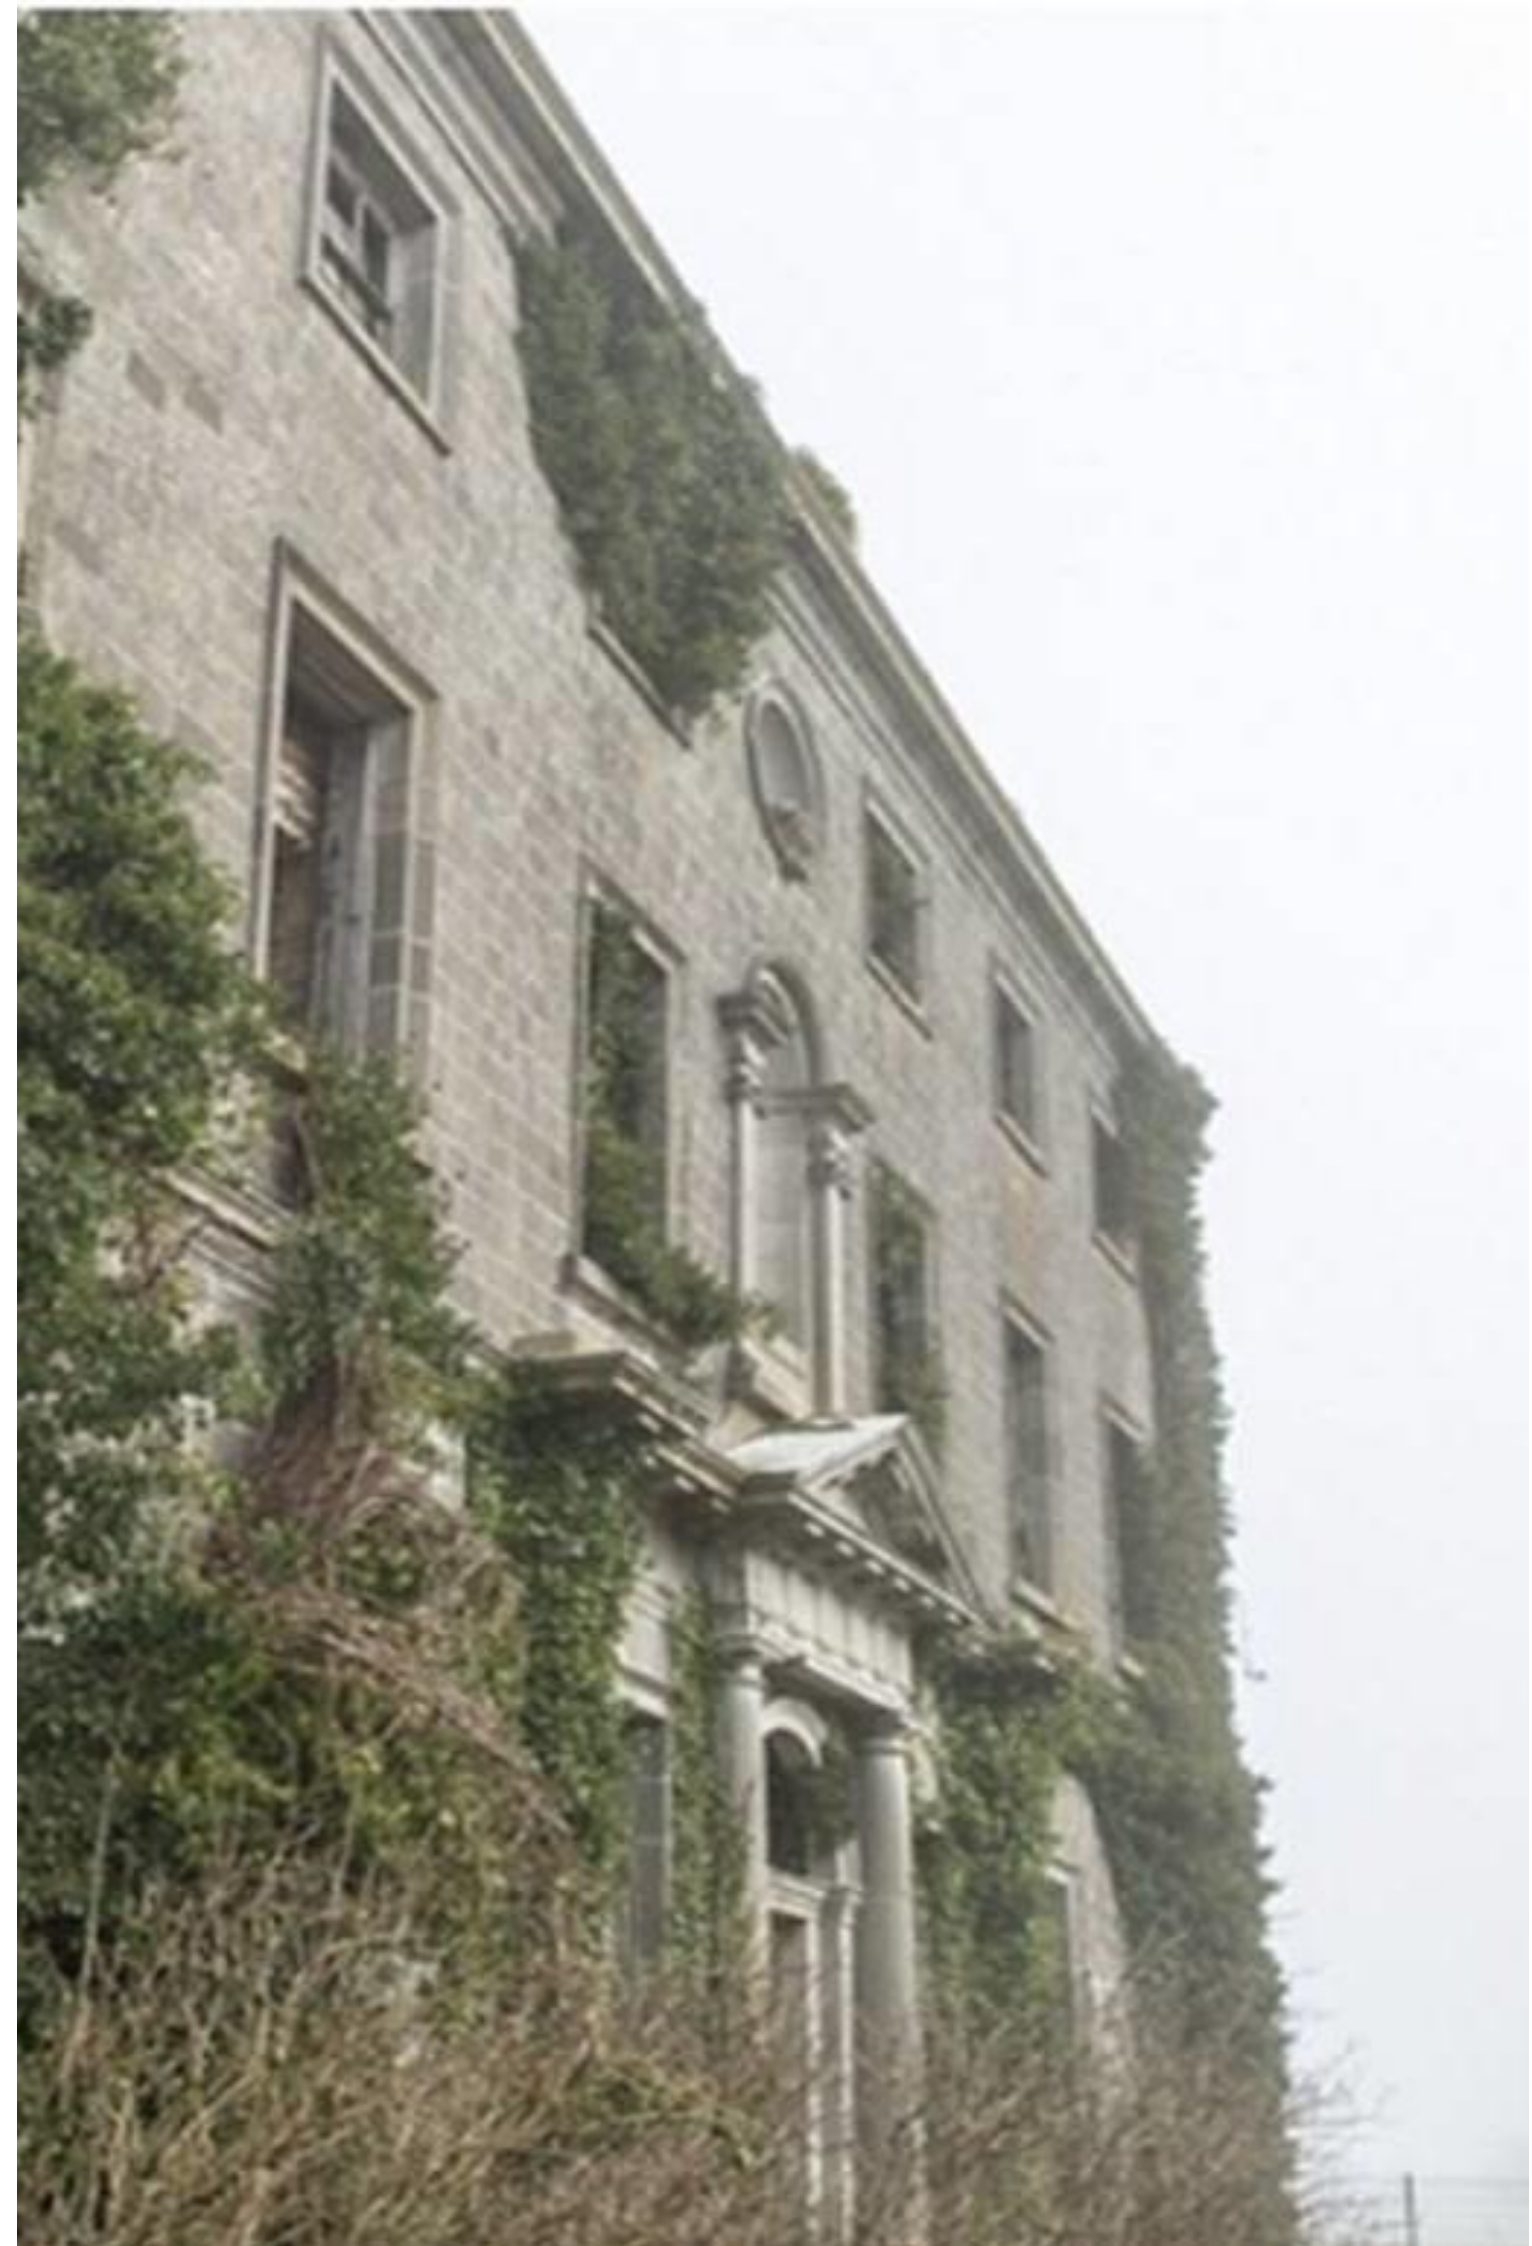
Tudenhams Park

Vacant with no identified new use	X
Suffering from neglect and/or poor maintenance	X
Suffering from structural problems	X
Fire damaged	X
Threatened with demolition	
Ruin which is poorly maintained

Condition of Structure	Very Poor
Level of Risk	High

The building is suffering from major conservation problems. Most of the external fabric remains, but there are obvious signs of deterioration such as slipped slates, vegetation growth, broken windows and vandalism. There is no immediate danger of collapse but condition is such that unless urgent remedial works are carried out the building will sharply deteriorate.

A mid 18th century limestone ashlar block built for George Rochford. His brother lived at nearby Belvedere House between which the Jealous Wall was built. The house was gutted in 1958 and has since become overgrown with vegetation. It requires immediate conservation works to secure the structure.

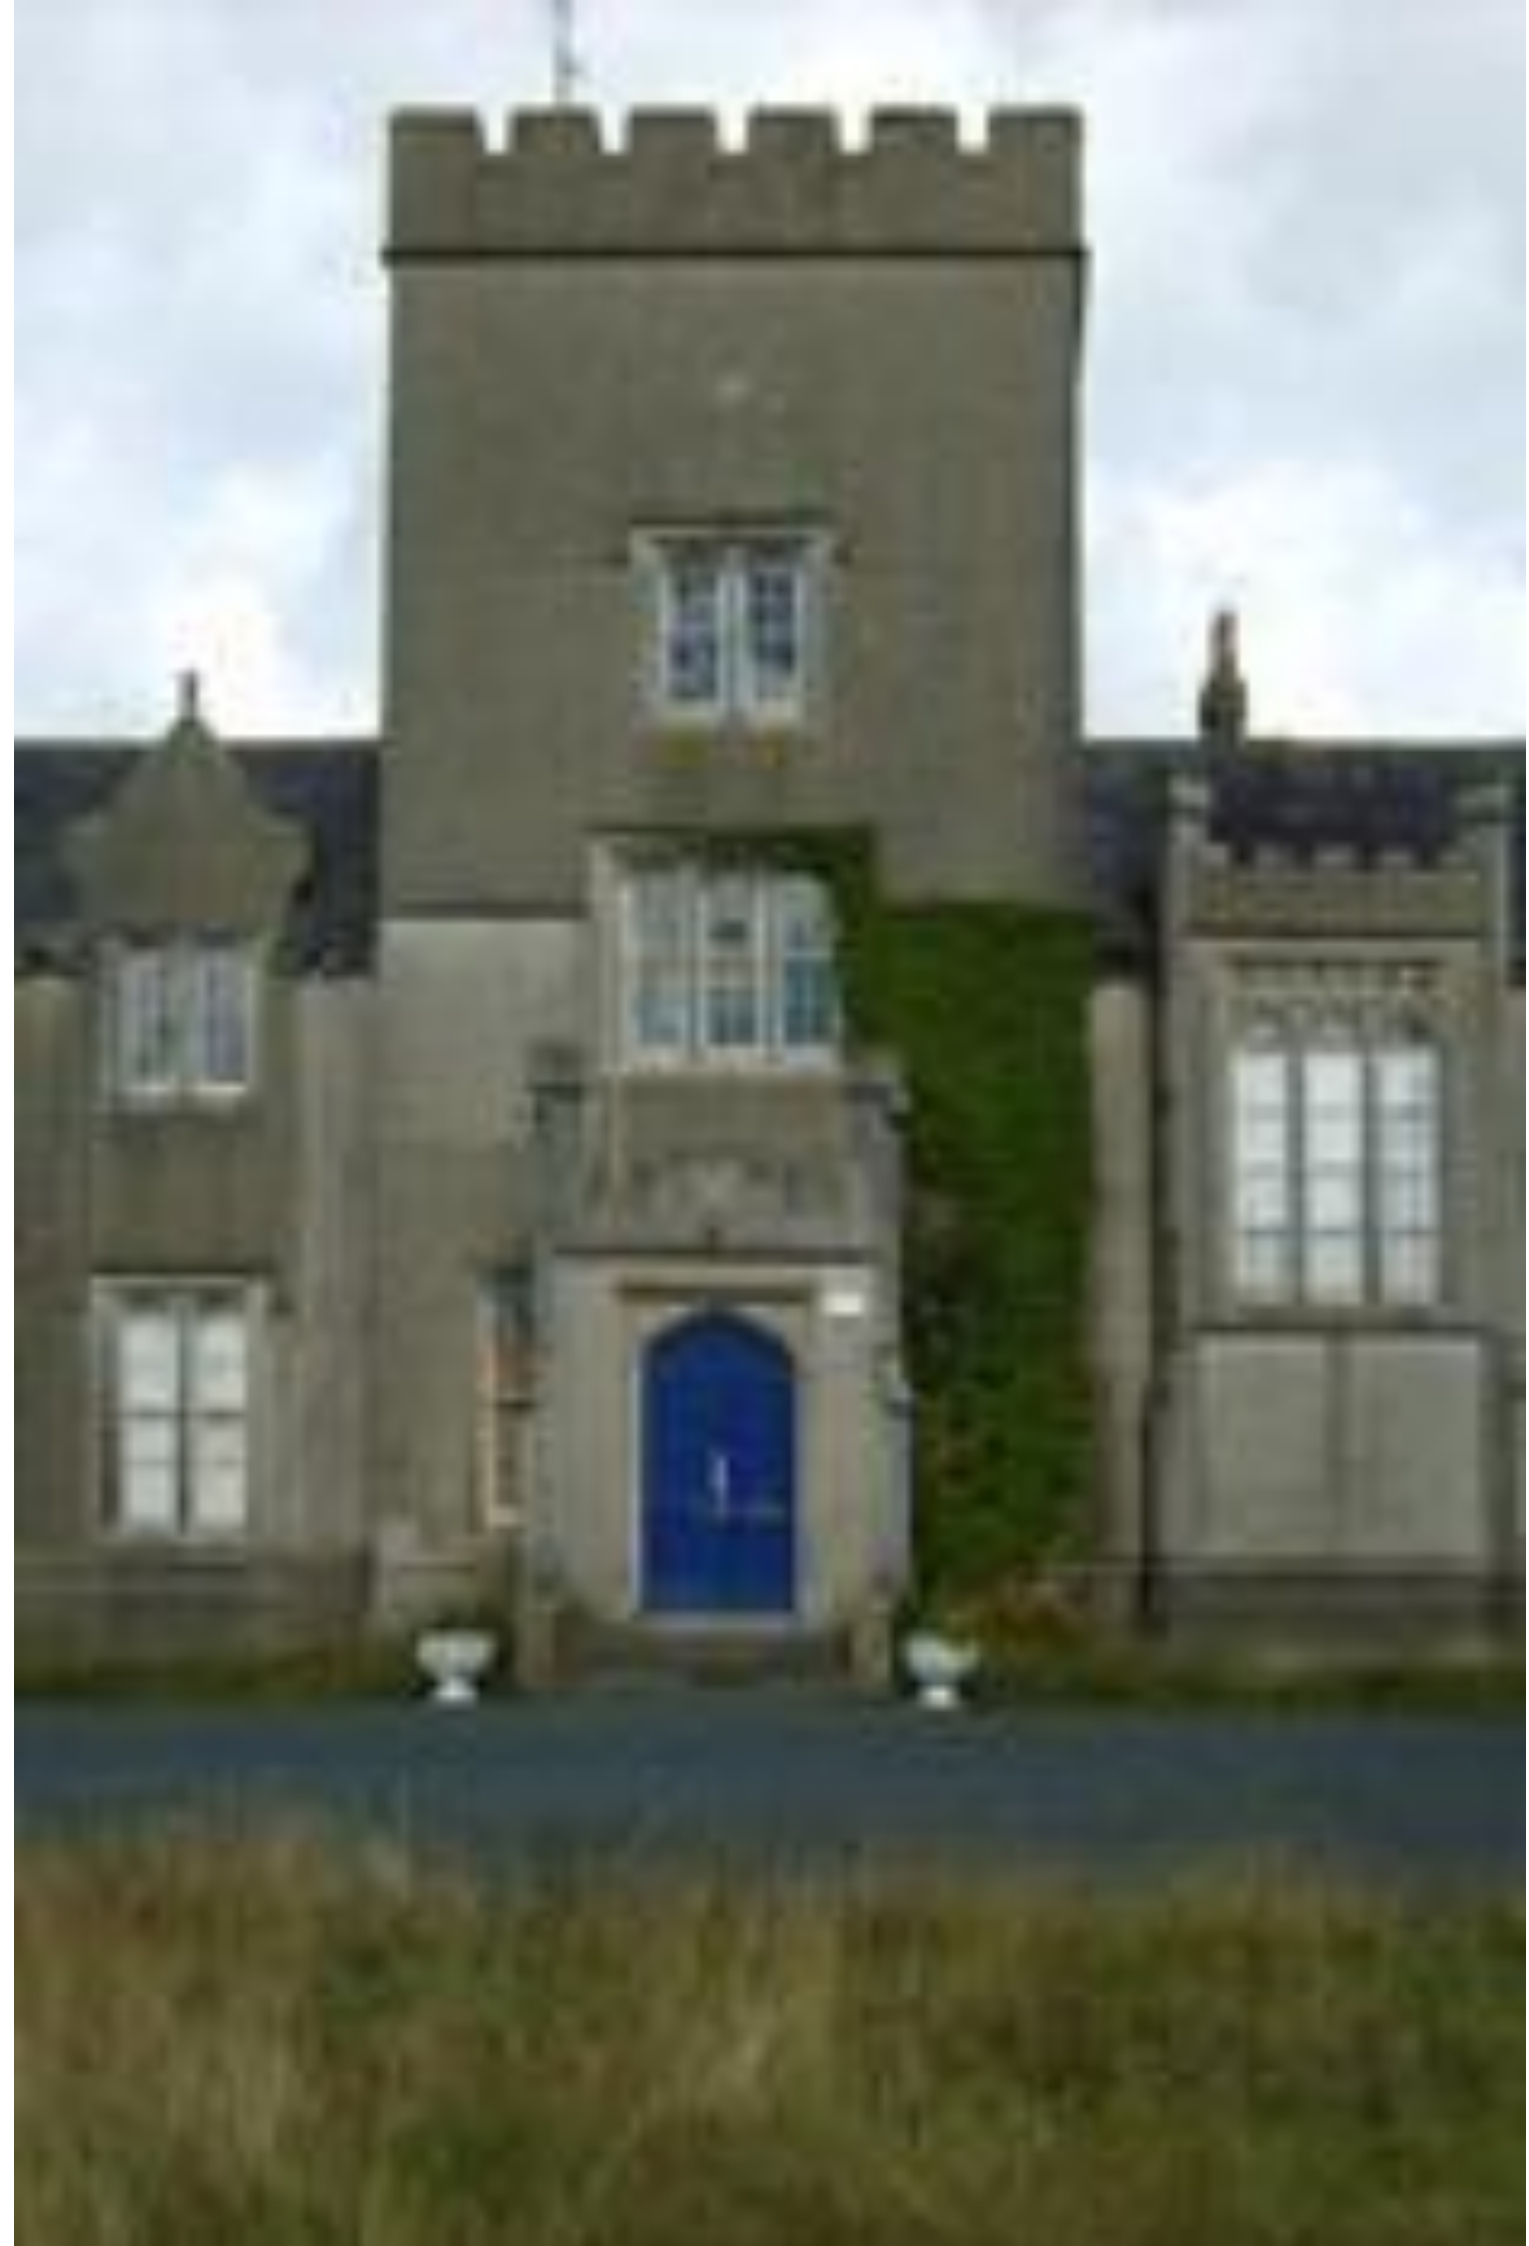
Cahore House

Vacant with no identified new use	X
Suffering from neglect and/or poor maintenance	X
Suffering from structural problems	
Fire damaged	
Threatened with demolition	
Ruin which is poorly maintained

Condition of Structure	Poor
Level of Risk	Moderate

The building has been vacant for a number of years and does not appear to be maintained. Most of the external fabric remains, but there are obvious signs of deterioration such as slipped slates, vegetation growth, broken windows and vandalism. There are concerns that the building could suffer further decay leading to more serious problems.

Permission for hotel and housing development was granted in 2007 (20053397). It is a mid 19th century Tudor revival house rendered with stone dressings. Gabled roof line and battlement tower. It was vacated by St. John of God religious institution. This building urgently requires new uses to be identified to prevent further deterioration of its character.
